# BELZONA PROTECTS GUIDE VEINS AT A HYDRO POWER STATION

ID: 9764

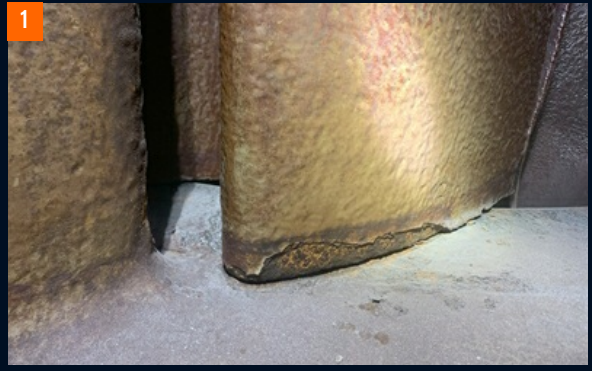
The existing coating on the guide veins at the end of the penstock at the entry point to the impeller of the turbine, was starting to show the effects of erosion and corrosion.

1. Existing condition of guide veins
2. Guide Veins after blasting
3. First Coat of 1341 Grey
4. Completed with second coat of Belzona 1341 Blue
