# BELZONA HELPS TO PROTECT HVAC END COVERS SUFFERING EROSION & CORROSION

ID: 9765

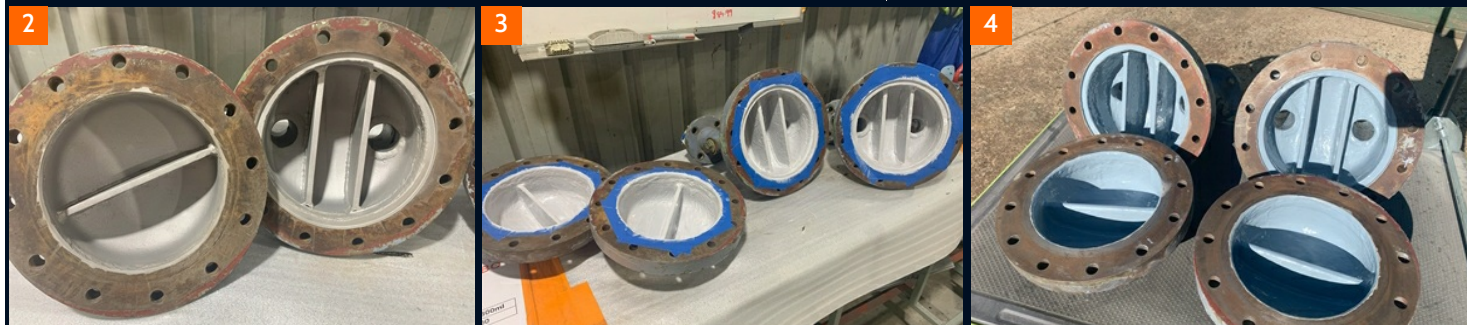
## PHOTOS

The asset owner was search for solutions for HVAC end covers that suffered from erosion and corrosion.

1. Existing condition of HVAC end covers suffered erosion & corrosion
2. End covers were blasted for further repair steps
3. First coat of Belzona 1391T Grey
4. End covers completed with second coat Belzona 1391T Blue

Belzona 1391T was recommend due to the elevated temperature of 85°C.

The end covers were abrasive blasted and coated with Belzona 1391T by the Belzona distributor for Australia, Rezitech Services team in Sydney.
