# BELZONA SOLUTION FOR INTERNAL REBUILDING & COATING OF PUMP DIFFUSER BOWL

ID: 9766

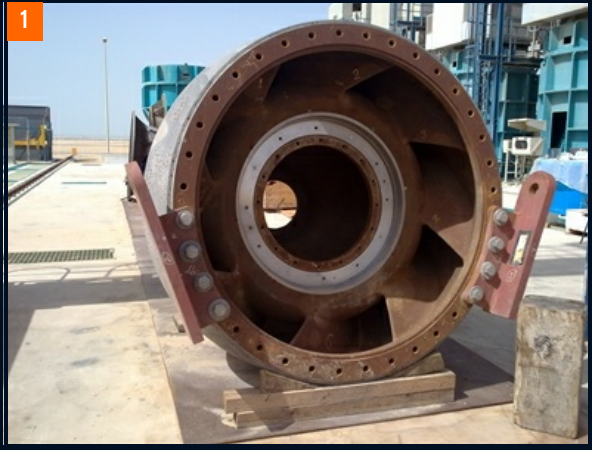
Extensive corrosion in a power station's seawater intake pump diffuser bowl and vanes from prolonged marine exposure is undermining efficiency, reliability, and structural integrity. A prompt corrosion-resistant solution is essential to improve durability, prevent equipment failure, and minimize maintenance costs.

1. Extensive corrosion in a power station's seawater intake pump diffuser bowl and vanes from prolonged marine exposure is undermining efficiency, reliability, and structural integrity.
2. After grit blasting, followed by cleaning with Belzona 9111.
3. The pitted areas were then rebuilt using Belzona 1311 (Ceramic R-Metal) as per the Belzona IFU
4. Finally, a two-coat system of Belzona 1321 (Ceramic S-Metal) was applied, adhering to the Belzona IFU guidelines.
