# BELZONA SUPERWRAP II RESTORES FUEL STORAGE TANK PIPELINE

**PROBLEM**  
Pipeline to storage tank was suffering from thin wall corrosion at the weld seam.

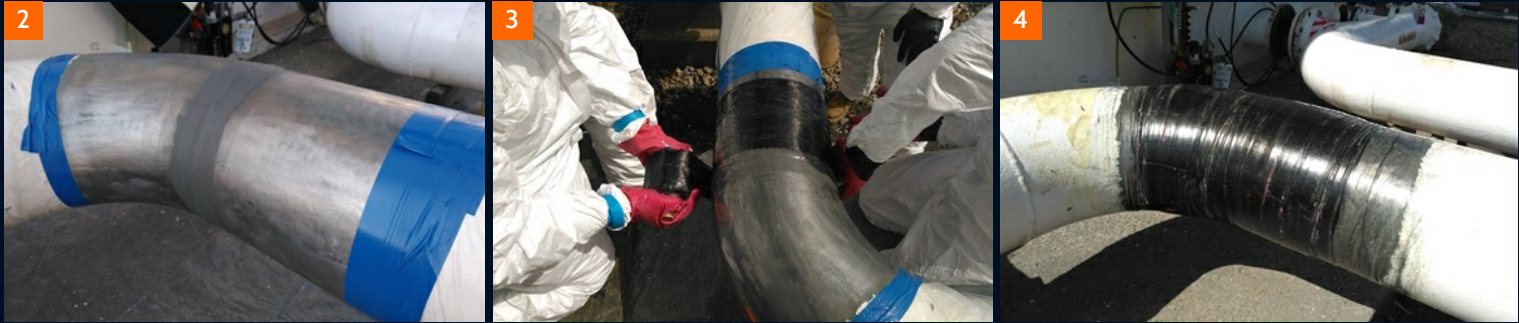
- PHOTOS**
- 1. Pipeline to storage tank.
  - 2. Surface preparation and weld seam rebuilt with Belzona 1212 E Metal
  - 3. Application of Belzona 9381 Reinforcement Tape
  - 4. Super Wrap II repair completed

**APPLICATION METHOD**  
Belzona Superwrap II 10-year compliant repair installed by the onsite Rezitech Services Team
