# BELZONA REPAIRS WINCH HOUSING ON A SHIP

ID: 9768

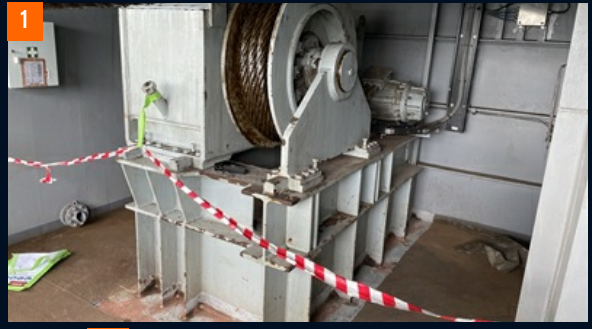
The base of winch housing was suffering from corrosion, raising concerns sea water would contact critical electrical equipment below.

1. Winch housing in question
2. Surface preparation prior to the application of Belzona system
3. Surface rebuilt with Belzona 1111 (Super Metal)
4. The rebuilt surface was overcoated with Belzona 5831 (ST-Barrier)
