# BEARING HOUSING REPAIR WITH BELZONA 1111

ID: 9769

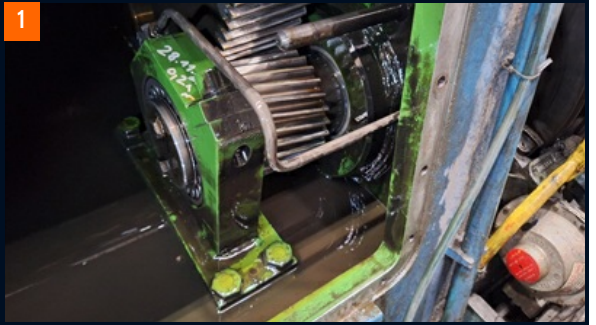
After prolonged operation, the bearing housing began to vibrate and lost its prescribed geometry. If it were to continue operating, there was a risk of damage to the entire gearbox.

1. Gearbox with damaged bearing
2. Treatment of damaged surface prior to application of Belzona 1111
3. Surface machining after application of Belzona 1111
4. Bearing after repair ready for reassembly
