# BELZONA REPAIRS ORNATE SCHOOL ENTRANCE PORCH

ID: 977

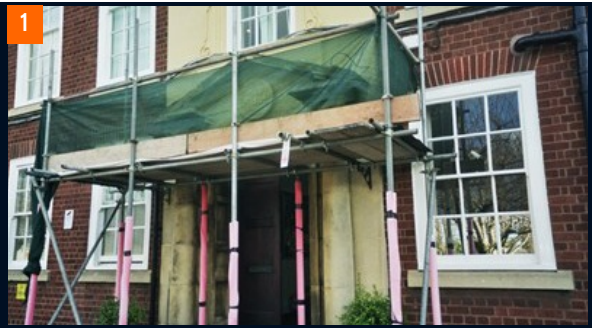
1. Entrance to School with scaffolding and barrier
2. Inspection of damaged stonework
3. Close Detail of damage
4. Completed application after 3 years of weathering

Application was carried out in accordance with Belzona Know-How System Leaflet WPA-6. Belzona elastomer used to take moulding copies from good areas. Belzona® 4141 then moulded to replicate the weathered areas.

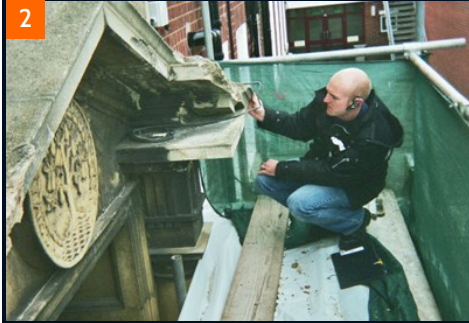
Parts of the cast concrete facade have been lost due to weather conditions, frost and snow in particular.
