# METAL PLATE BONDING ON DAM STRUCTURE

ID: 9774

## PROBLEM

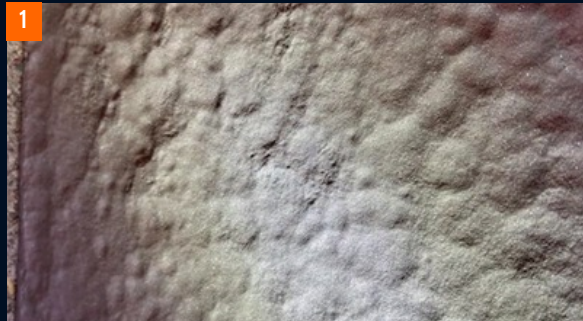
Dam structure was badly worn by erosion of river running beneath and it required reinforcement. Due to the areas affected, welding was not an option. Engineering consulting company specified Belzona to bond metal plated to the structure for reinforcement and corrosion protection.

1. Structure before metal bonding.
2. Structure after metal bonding with Belzona 1121.
3. Perimeter of the bonded area coated with Belzona 5811.

Existing structure and plate was blasted to SSPC SP10 standard of cleanliness. Belzona 1121 was applied on both the structure and the plate for a wet on wet application. Due to freezing conditions, heater were put on to enable proper curing at favourable conditions. Belzona 5811 was then applied to seal the perimeter around the bonding area. Necessary inspections were carried out after few weeks and application was certified okay.
