# BELZONA HELPS WITH STERN TUBE REALIGNING

ID: 9775

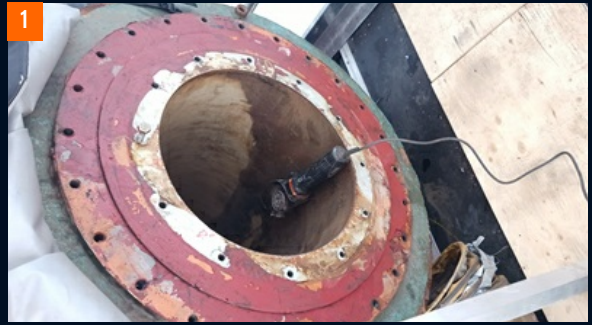
1. Stern tube after cleaning.
2. Belzona 1111 application completed.
3. Machining down to required dimensions.
4. Belzona 1321 application completed.

Affected stern tube lining was blasted to the level of cleanliness as instructed in the product IFU. Surface was degreased and Belzona 1111 was applied and machined to the required dimension. Two coats of Belzona 1321 were applied afterwards to seal the area. The application was inspected and passed for the alignment of the propeller.
