# COOLING TOWER LIFELINE

ID: 9778

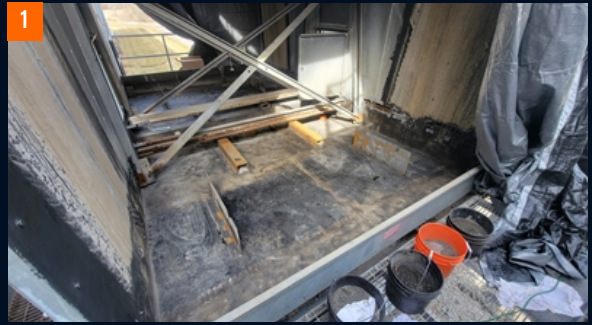
These towers were reaching the end of their life cycle, there was large holes above the liner and several small pinhole leaks throughout the entire water basin. Without treatment, they would need to be replaced soon.

1. After sandblasting it became very apparent of the extent of the damage and the areas that needed to be focused on.
2. You can see the areas that had been complete rusted through.
3. Repairs were made to make the surface whole again.
4. After two coats of Belzona 5811 this tower was ready for many more years of service.

The old fill was removed in preparation for the Belzona coating. This ensured access to the entirety of the cold-water basin. The entire surface was grit blasted, and all severely damaged areas were treated with sheet metal and Belzona 1121 to regain structure for coating. This was immediately followed by a coat of Belzona 5811. The second coat of Belzona 5811 was applied the following day. Afterwards a thorough inspection and touch up process took place to ensure that all areas were protected and sealed. New fill was replaced, and the tower was returned to service!
