# BELZONA REPAIRS COOLING TOWER

ID: 9779

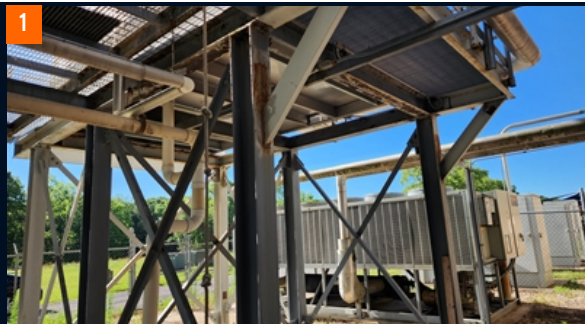
1. Several areas of the structural steel were rusting, the customer was concerned about having to replace these down the road.
2. Rather than spot repair the areas, it was elected to blast and coat the entirety of the steel supports.
3. Belzona 3921 was sprayed to all areas after a brush blast. Then a coat of Belzona 5111 was sprayed to all the prepared areas.
4. The finished solution should provide substantially more protection long term than the simple paint that was applied before.
