# LEAK REPAIR AT BLOWDOWN ELBOW AT POWER PLANT

ID: 9781

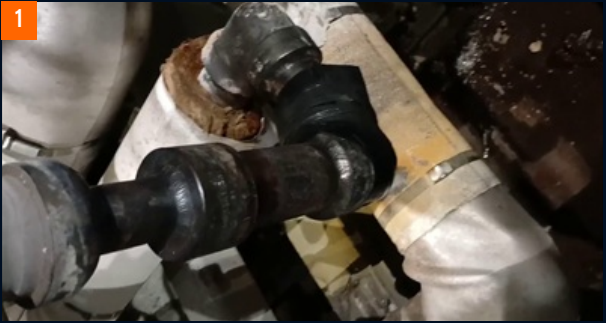
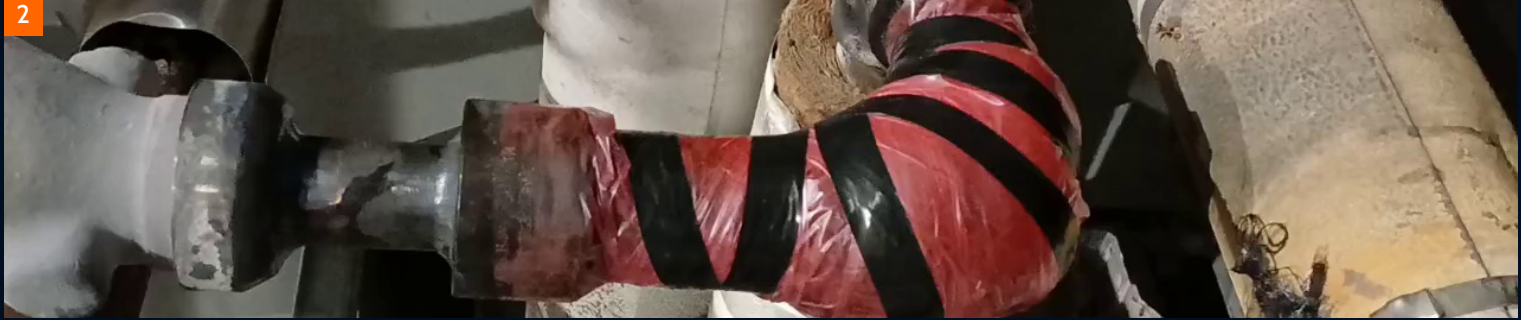
A high-pressure steam leak was identified at the blowdown elbow of an industrial piping system. The leak posed a significant risk to operational efficiency, safety, and environmental compliance. The challenge was to execute a durable, long-term repair without requiring hot work or extended downtime. Traditionally, they used 3D modeling and epoxy injection, which was costly for them. So, they were in search of an economical solution.

1. Leak arrested by Belzona 9611 and wrapped by tourniquet
2. Repair consolidated by Belzona Superwrap II (Belzona 1983 (resin) + Belzona 9381 (Cabron fiber) + Belzona 9382

Surface Preparation:  
The affected area was thoroughly cleaned to remove contaminants, rust, and debris. Mechanical abrasion was performed to enhance adhesion. The area was degreased using Belzona 9111 cleaner to ensure a dry and contaminant-free surface.  
Leak Sealing with Belzona 9611:  
Since the steam flow was shut down but dripping persisted, Belzona 9611 was applied to arrest the leak effectively.  
Reinforcement & Strengthening with Belzona SuperWrap 1983, 9381, and 9382:  
The area was wrapped using the Belzona SuperWrap 1983 system, incorporating Belzona 9381 and 9382 for enhanced structural reinforcement.  
Curing & Inspection:  
The repaired area was allowed to cure as per the recommended time. A thorough inspection was conducted to ensure a leak-free and structurally sound repair.
