# BALER INTERIOR WAS RESCUED FROM WEAR.

ID: 9783

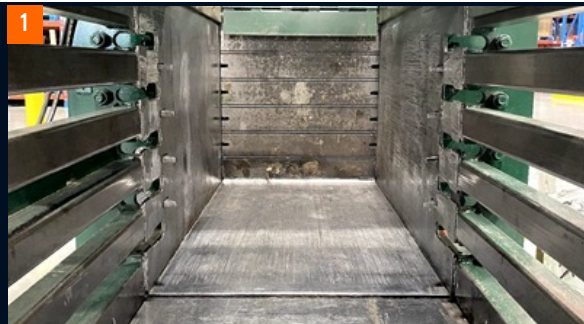
The lining of the baler was experiencing wear due to ramming of the loader. Plates could not be welded to both sides due to the thickness requirements. Belzona was consulted, we gave various options and customer picked that of rebuilding with a paste grade product.

1. Baler lining after power tool cleaning before application of Belzona 1121.
2. Side view of cleaning.
3. Side view of application.
4. Both sides after application.

Power tool were used to clean the surface and created required profile. Belzona 1121 was mixed and applied, then smoothed to give a more uniform application for ease of ramming of the loader. Equipment was put to test and customer was satisfied with the result.
