# BELZONA SOLUTIONS FOR RUBBER BALLOON CRACK REPAIR

ID: 9784

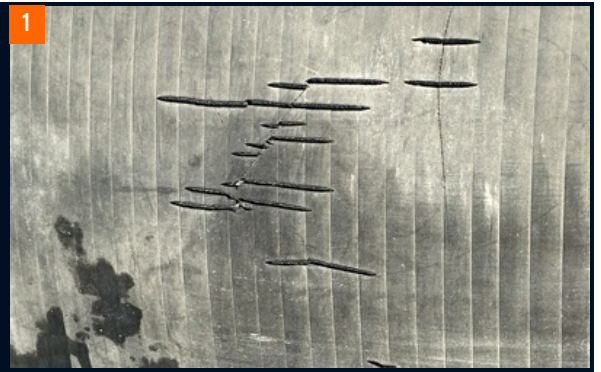
A marine customer has reported severe cracking in their floating rubber balloons, primarily due to dredging activities in the sea. The dredging process has caused the balloon surfaces to come into contact with sharp debris, leading to punctures and fractures. Additionally, strong water currents and sediment movement have intensified the stress on the balloons, further worsening the damage. Consequently, the customer is struggling to maintain the structural integrity of the balloons, impacting both operational efficiency and the safety of their marine operations.

1. Significant cracking in their floating rubber balloons, mainly caused by dredging operations in the sea.
2. The process started with surface preparation and cleaning using Belzona 9111 (Cleaner Degreaser).
3. The damaged areas were subsequently repaired and reconstructed using Belzona 2211 (MP Hi-Build Elastomer).
4. The final layer of Belzona 2111 (D & A Hi-Build Elastomer) was applied for added protection.
