# BELZONA REPAIRS AND STRENGTHENS SEVERE THROUGH WALL SLIDING ABRASION TO ASH PIPEWORK AT AN ENERGY RECOVERY PLANT

ID: 9785

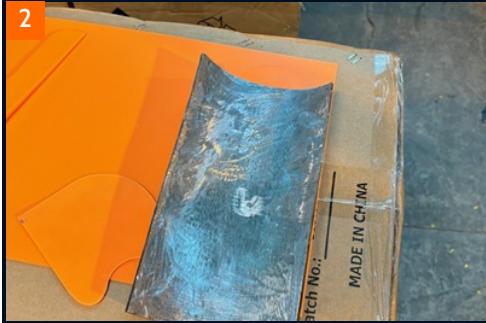
1. Pipe showing the large hole caused by sliding abrasion. Photo shows the pipe after surface preparation and starting to apply Belzona 1511 Super High temperature metal for the patch to be bonded onto.
2. The Steel patch after surface preparation both sides, which is going to be bonded over the large elbow hole.
3. The steel patch now bonded into place over the hole and clamped with two strap clamps.
4. Belzona 1983 SuperWrap II has now been applied over the pipe elbow, covering the new patch and 200mm each side of this to give some structural Integrity back to the chute. Release film is being applied tightly to consolidate the application.

A stainless steel patch was cut from a similar sized spare pipe to be bonded over the through wall areas and this was prepared on both sides. The plate was then bonded over the holed elbow with Belzona 1511 Super High temperature metal and held in place with strap clamps until the Belzona 1511 had cured sufficiently. The straps were removed and Belzona 1983 SuperWrap II was applied in several layers to strengthen the thin pipe on the elbow and either side of the patch repair.
