# POWER PLANT HYDROCYCLONE REPAIRED WITH BELZONA

ID: 9788

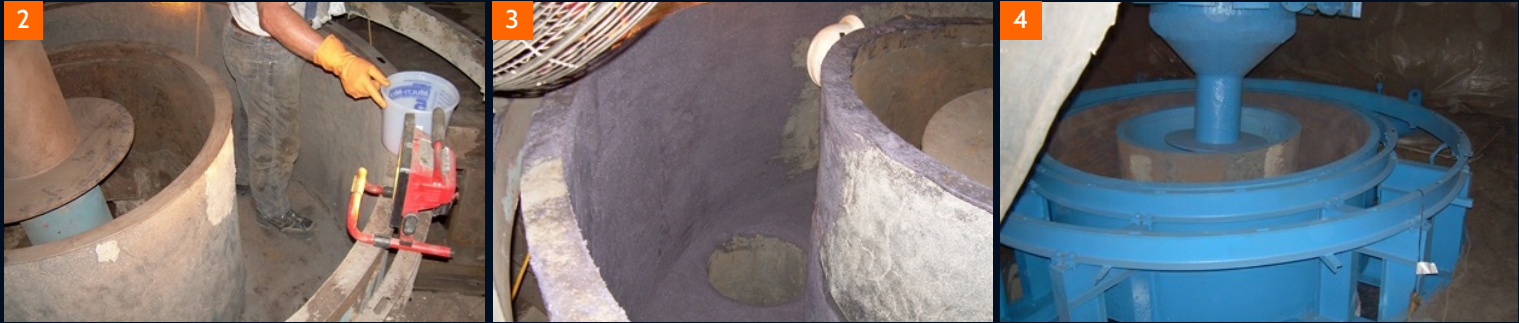
**PROBLEM**  
Severe wear due to abrasion caused this hydrocyclone to lose its efficiency.

- PHOTOS**
- 1. A well used Hydrocyclone
  - 2. Applying Belzona 1811 (Ceramic Carbide)
  - 3. Belzona 1811 (Ceramic Carbide)
  - 4. Finished application and fresh paint

**APPLICATION METHOD**  
Unit was grit blasted to SSPC SP 10 then washed down with MEK. Belzona 1811 (Ceramic Carbide) was mixed and applied according to the products Instructions for Use.
