# BELZONA 4181 REPAIRS SECONDARY CONTAINMENT SYSTEMS IN SWEDEN

ID: 9789

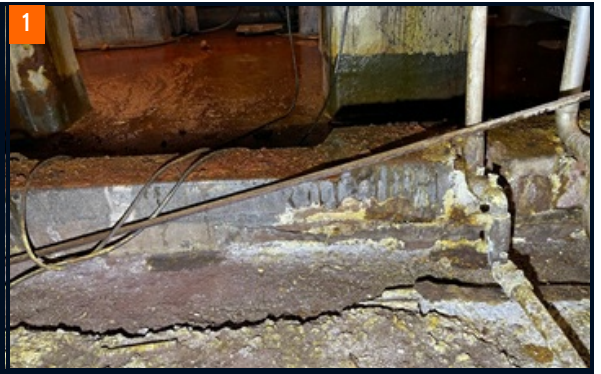
The highly corrosive environment (hydrofluoric, nitric and sulfuric acid) of this secondary containment area below a pickling line was suffering extreme erosion on the 550m<sup>2</sup> of concrete and its failing GAP-coating.

1. Extent of the chemical attack.
2. Belzona 4181 rebuilding the damage.
3. Application in progress.
4. Completed.
