# BELZONA MEMBRANE TO THE RESCUE

ID: 979

Felt roof over hotel restaurant.

Hotel, Edinburgh, Scotland

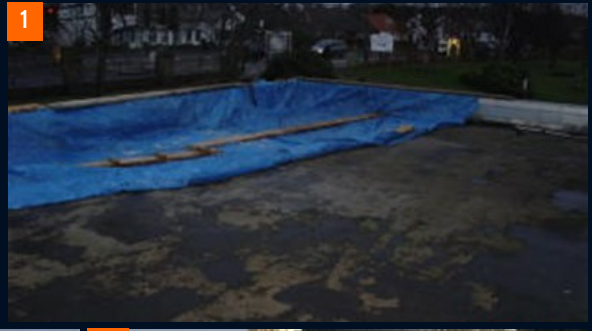
1. View of the "tired" and uncoated roof
2. Area where water was penetrating
3. Completed gutter, the main problem area
4. Completed Belzona application

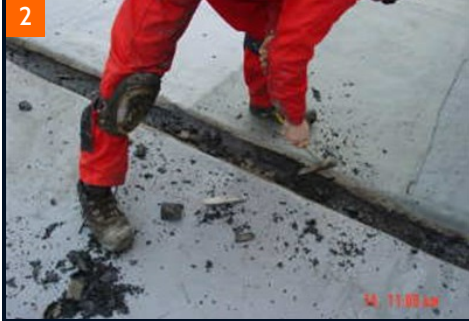
Water penetrating gutter joints due to weight of water on the joints. Owner required immediate repairs to prevent disruption to business.
