# ENCAPSULATION OF VIKING PIPE CLAMPS ON 800MM DIA. WASTE WATER PIPE

ID: 9793

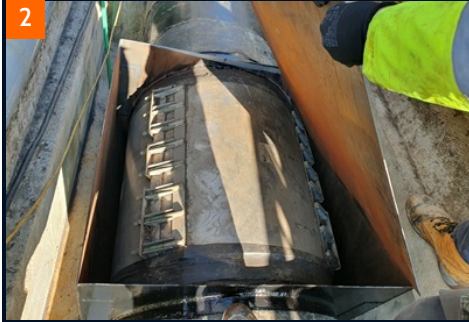
Steel shuttering was fabricated and fixed into place around the Viking Clamps.

1. View of clamps
2. Steel frame placed into position
3. 50% poured
4. Finished application

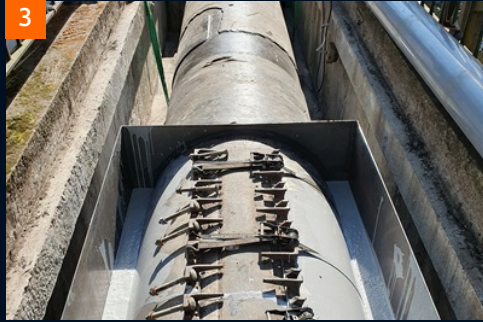
The Belzona 4111 was mixed as a pourable slurry and poured into the steel shuttering until

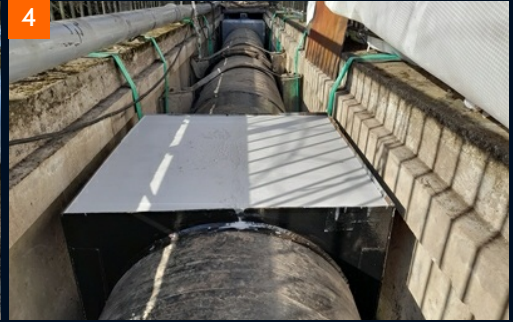
The level was 50mm above the top of the clamps.
