# HEAVILY ERODED HEAT EXCHANGER COMPONENTS ARE REVITALISED

ID: 9797

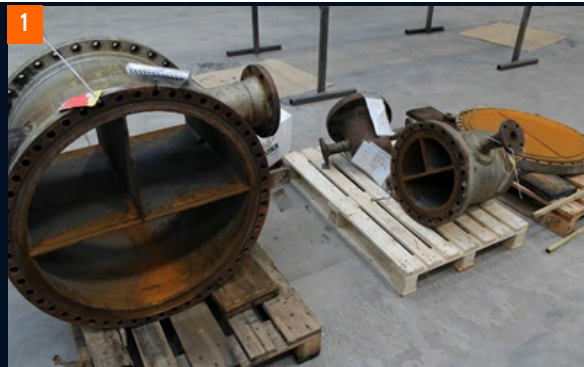
Each component was in a heavy state of erosion suspected from chemical attack. After surface preparation, the components were reprofiled with Belzona 1511, then coated with Belzona 1391T to protect the components from future chemical attack.

1. Heavily eroded heat exchanger components were in need of repair
2. Components are grit blasted back to expose eroded areas and produce a minimum surface profile
3. After the components are reprofiled using Belzona 1511, the first coat of Belzona 1391T is applied
4. Two coats of Belzona 1391T and the components are protected against erosion and ready to go back into commission

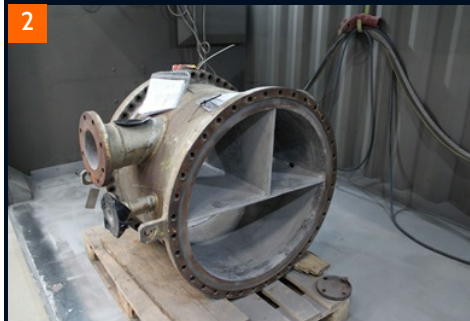
Substrate preparation was carried out with conventional grit blasting with an angular abrasive to achieve a minimum surface profile of 75µm and a surface cleanliness of SA 2½.

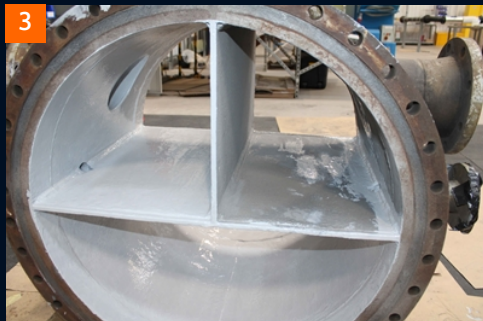
Following surface preparation, technicians applied Belzona 1511 to areas requiring reprofiling, restoring the internal body to an acceptable condition.

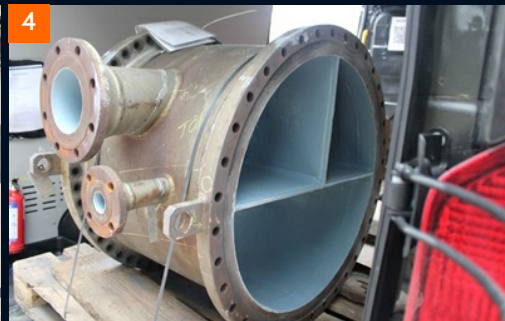
Where the internal diameter of nozzles were under 75mm, premanufactured nozzle inserts were installed. A two-coat system of Belzona 1391T was applied, with each coat achieving a target thickness of 450µm.
