# REPAIRS TO FLATS BALCONIES AND WALKWAYS

ID: 9798

After being approached on a safety issue, Belzona were asked to supply a solution to make good spalled concrete areas and provide a safe walkway to a number of flats in the Nottingham area

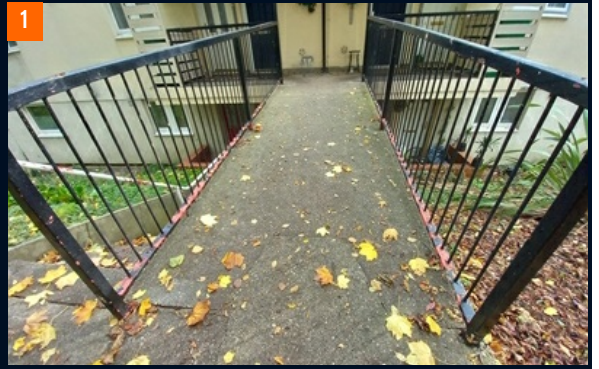
1. Balcony before application
2. Stairs before application
3. Stairs after application
4. Stairs after application

All concrete repairs were prepared according to IFU and System Leaflet WPA4

Application to all damaged areas using Belzona 4911 and Belzona 4141 Belzona 3131 was applied to the walkways and stairs using Granogrip, blinded into the second coat to offer a full grip system
