# STEEL PANEL TANKS SUFFERING FROM CORROSION

ID: 9799

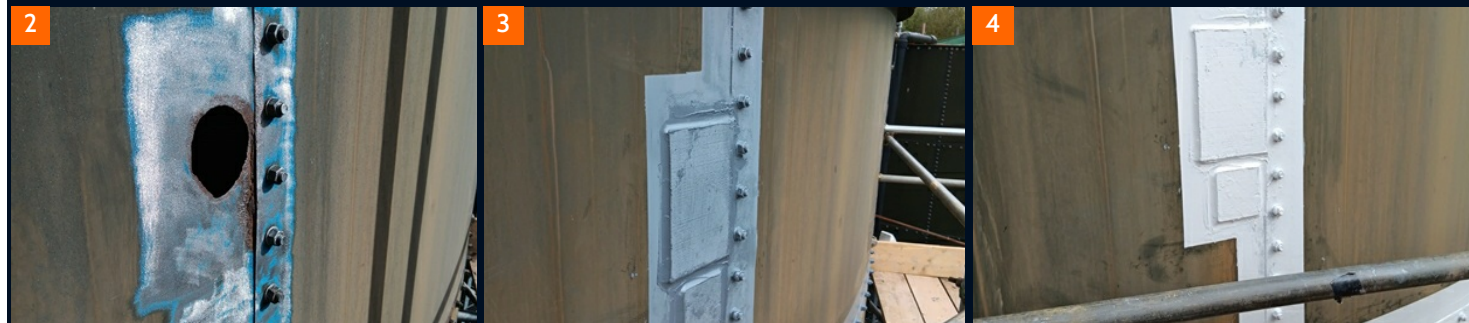
A wastewater site with typical glass-infused steel panel tanks were experiencing leaks due to internal chemical attack and environmental exposure, resulting in localised through-wall defects and seam failures.

1. Through wall defects from internal chemical attack and environmental exposure
2. Surface area cleaned and prepared to minimum surface profile
3. Composite plate bonded with Belzona 1111
4. For added protection, all affected areas were then coated with Belzona 3131

To restore integrity, all identified areas were thoroughly cleaned and prepared before cold bonding Belzona SuperWrap II composite plates to all defects using Belzona 1111.

Belzona 1111 was also applied to areas of concern along the seam lines to bring back to their original profile.

For added protection, all affected areas were then coated with Belzona 3131, restoring performance and extending service life.
