# IN-SITU BELZONA REPAIR TO DRYER ROLLER

Bearing journal on dryer roller of paper machine

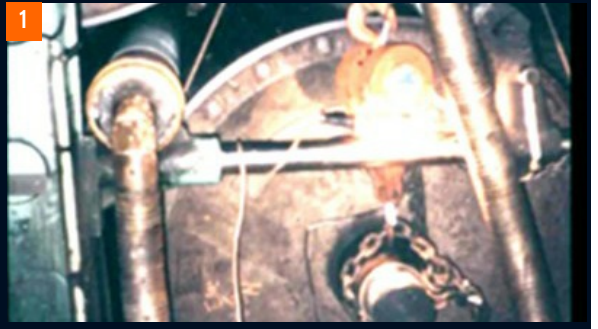
Collapse of bearing caused damage to the journal

1. General view of the damaged drying roller journal
2. Former clamped in place
3. Former removed showing accurately rebuilt journal
