# BELZONA HOT OFF THE PRESS

Large hole torn in the belt caused by a metal tool being dropped onto the belt.

Conveyor belt carrying rejected newspapers.

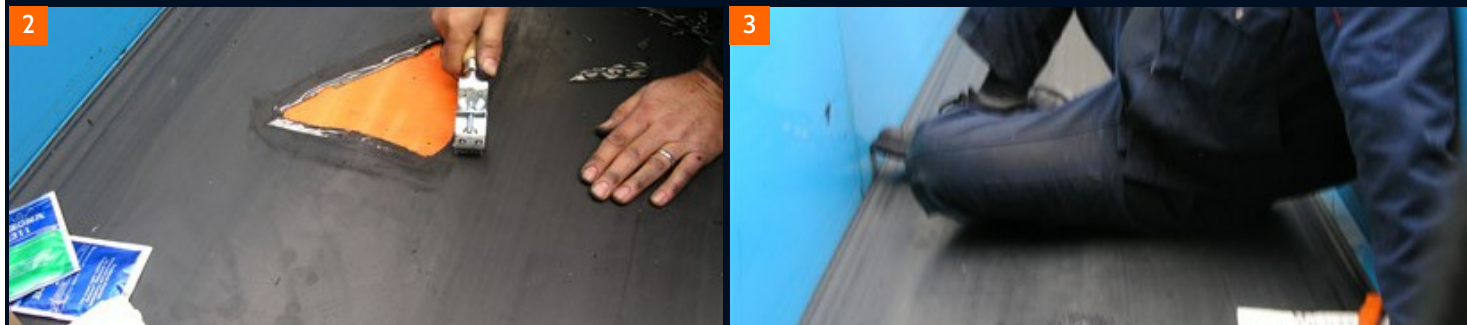
## PHOTOS

1. Damaged belt
2. Preparation in progress
3. Finished application, with customer admiring his work

Application was carried out in accordance with Belzona Know-How System Leaflet SHM-1.

Due to the nature of the customers business and the need for this particular belt to be running almost 24 hours a day seven days a week, it was impossible to replace the belt and would cost around £3000. Utilising the Belzona system it cost them around £40 in materials and they got the belt back up and running within 2 hours, in time for the next print run.
