# REPAIR AND COATING OF EROSION CORROSION DAMAGE ON THE MAIN ENGINE COOLER COVER

ID: 9800

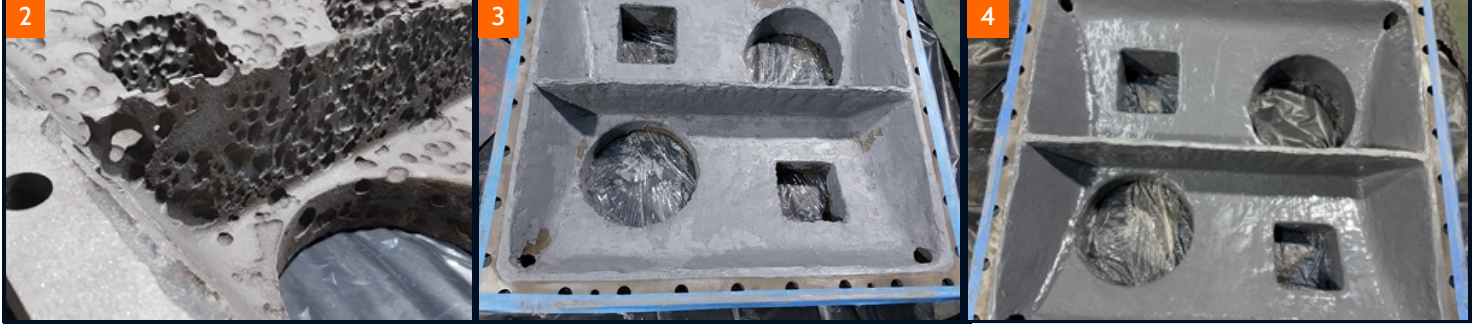
Metal losses and severe pittings occurred in the main engine cooler cover due to erosion and corrosion. The customer wanted to repair and protect the equipment with Belzona against future erosion and corrosion damage.

1. After SA 2.5 steel grit blasting
2. Severe metal losses
3. After repair with Belzona 1111 Super Metal
4. After coating with 2 layers of Belzona 1321 Ceramic S-Metal

Main engine cooler cover of bulk carrier ship. Customer wanted to repair the cover in short time. Instead of welding repair, Belzona saved time and in addition provided long lasting protection with ceramic coating.

Repairing the equipment with other repair methods (such as welding) would be a long and costly method. Since these damages would occur again even if repaired with welding, the customer wanted to repair the equipment with Belzona and then protect the equipment against future wear and corrosion-erosion damage. We repaired the equipment with Belzona 1111 Super Metal within 1 day and protected it with Belzona 1321 Ceramic S-Metal. In this way, the customer saved both time and money also protected the equipment.
