# BELZONA SUPERWRAP II REPAIR & REINFORCEMENT OF SEAWATER PIPELINES ON LNG SHIP

ID: 9801

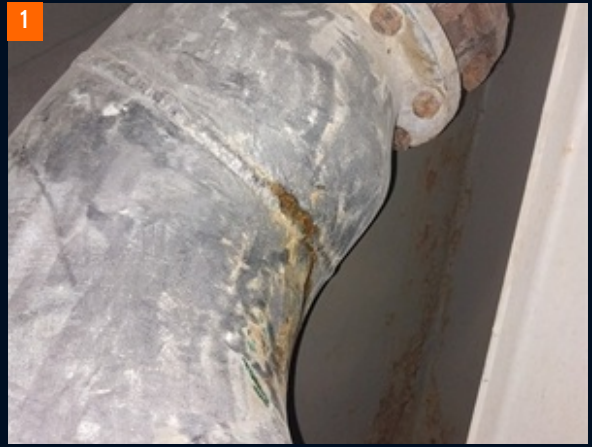
The CuNiFe seawater pipelines ranging between DN65 to DN300 on an LNG ship were weakened and leaking due to corrosion. Customer choose to repair the leaks and reinforce thinned pipelines with Belzona SuperWrap II.

1. Weakened and leaking areas in the pipelines.
2. The leaks were repaired by with Belzona 1212.
3. Belzona SuperWrap II has been applied on DN300 pipelines.
4. Belzona SuperWrap II has been applied on DN200 pipelines.

Surface preparation was carried out by power tool cleaning SSPC-SP11. The surface was cleaned with Acetone and allowed to dry. Then, Belzona 1212 was applied to the leaking areas. After Belzona 1212 was cured, its surface was sanded down and then the Superwrap II fiber wrapping system was applied onto prepared pipe surfaces. Finally, application sections were consolidated with release film and left to cure.
