# BELZONA ELIMINATES TRIPPING HAZARDS AT A MEDICAL FACILITY

ID: 9804

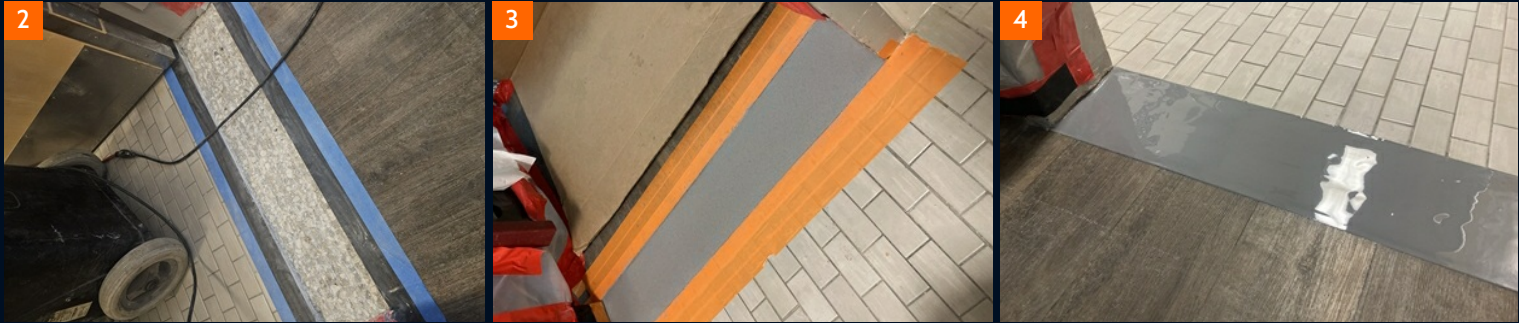
An uncomfortable step was creating serious problems on the transition from rooms to bathrooms at a healthcare facility. The patients were tripping at a serious pace. Belzona came to the rescue.

1. Existing transition from room to bathroom.
2. Removal of tripping hazard and surface preparation.
3. A new transition created with Belzona 4131.
4. Belzona 4411 applied as topcoat.

Application was carried out in accordance with Belzona System Leaflet FPA-1. After removing existing tripping hazard and excavating to create a solid foundation, Belzona 4131 was used to fill the space. Then, Belzona 4411 was used to complete a smooth transition.
