# BELZONA RESCUES AN AIR HANDLER UNIT OVER THE WEEKEND

ID: 9805

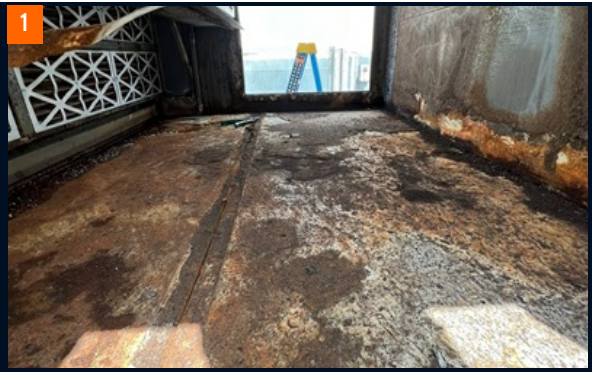
The internal surfaces of the air handler suffered from heavy corrosion due to lack of maintenance and poor performance coatings. Corroded section required removal, new metal was bonded and protective coating was applied to extend the life.

The units was severely corroded to the point of significant metal loss. The rust needed to be removed, new metal was bonded, and coating was required to protect and extend the life of this unit.

1. Air handler unit condition before Belzona treatment
2. New metal was bonded using Belzona 1161
3. Air handler unit after application of Belzona 5831
4. Air handler unit after application of final coat of Belzona 5811

Corrosion was removed using power tools. Most of the metal was cut out, and replaced with new metal using bonding techniques. Then, one coat of Belzona 5831 and a final coat Belzona 5811 were applied.
