# EVAPORATOR HEAT TRANSFER TUBE

ID: 9807

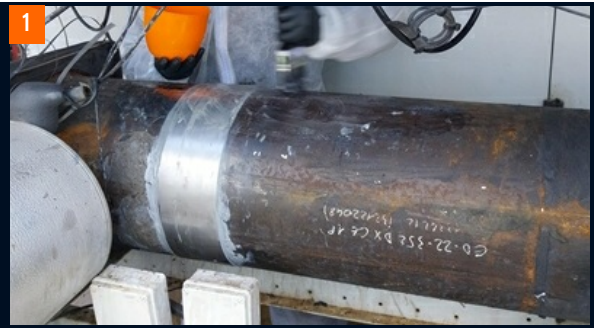
1. Showing one of the end anchor points bonded to the tube with Belzona 1161
2. Wrapping the tube after wetting out the tube and composite wrap
3. Wrap completed
4. All layers and bespoke ends applied and revisited 3 months on. The customer is totally happy, with no leaks and completely dry floors and dry machinery,

2 collars were fabricated and prepared with power tools. These were to be bonded at each end of the tube with Belzona 1161 to give anchor points for the Belzona 1984 Superwrap II application

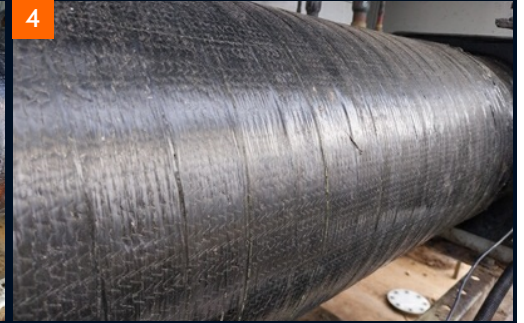
\*UPDATE - Engineering team exceptionally happy and delighted with the result and cost savings against other methods and solutions
