# BELZONA RESTORES SCHOOL TOWER

ID: 981

Two stone towers connected with a wrought iron construction at the top of an old school building.

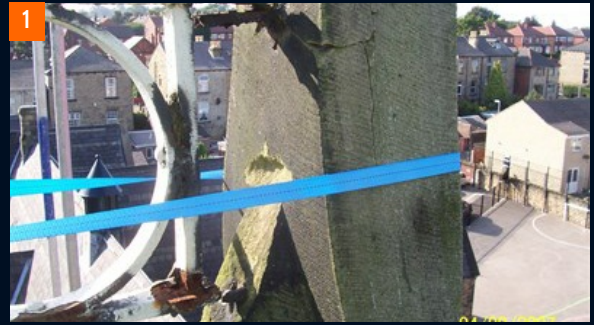
Cracking and spalling of 2 stone towers and corrosion of connecting wrought iron metalwork created a Health & Safety risk.

1. The problem
2. Stone removal
3. Completed rear tower
4. Completed work

Application was carried out in accordance with Belzona Know-How System Leaflets WPA-4 & 8. The stonework was rebuilt with Belzona® 4231. Belzona® 1111 used to rebuild corroded wrought iron before protecting with Belzona® 6111/5111 system. Belzona® 5122 applied to stonework for long term protection.
