# BELZONA SOLUTIONS FOR REBUILDING AND COATING OF TUBE SHEET AND END COVER OF THE HEAT EXCHANGER

ID: 9811

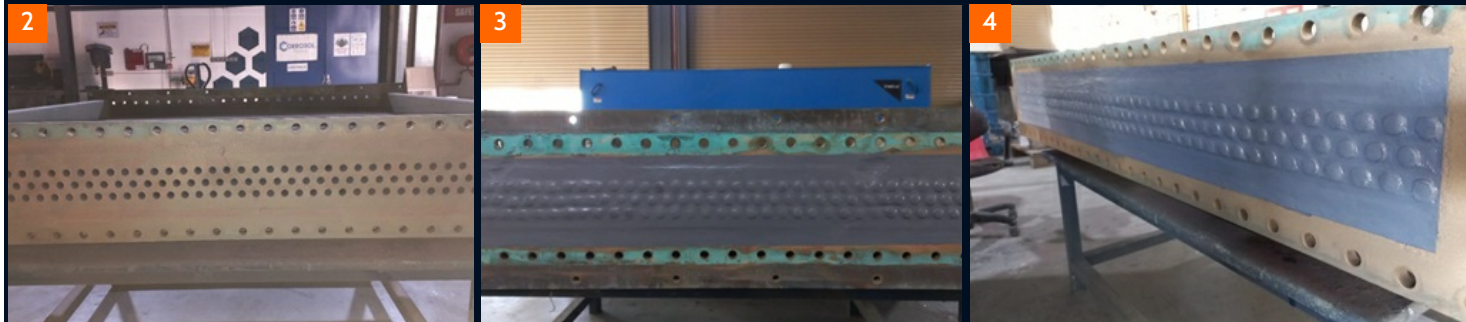
The heat exchanger tube sheet and cover suffered from metal loss and severe pitting as a result of erosion and corrosion. The customer sought a solution to repair the damage and protect the equipment from future erosion and corrosion using Belzona.

1. The heat exchanger tube sheet and cover suffered from metal loss and severe pitting as a result of erosion and corrosion.
2. The front surfaces of the tube sheet and cover (including the internal sides) were blast-cleaned to the required standards (Sa 2.5 with a minimum surface roughness of 75 µm), followed by desalination and re-blasting.
3. Pipes were plugged, and damaged areas were sealed with a 3–5 mm thick layer of Belzona 1111.
4. Belzona 5892 was then applied in two sequential coats, achieving a total dry film thickness (DFT) of 500 µm.

Belzona 1111 was used to create a solid, uniform surface that does not shrink or expand during curing, ensuring tight joints around the tubes. For long-term protection, Belzona 5892—a two-component, solvent-free coating designed for high-temperature performance—was applied. It offers excellent protection for both metallic and non-metallic surfaces under immersion conditions at operating temperatures up to 203°F (95°C) and can withstand steam-out conditions up to 410°F (210°C).

The application was carried out in accordance with Belzona Know-How System Leaflets HEX-1 and HEX-2, ensuring compliance with industry best practices for corrosion protection and equipment longevity. The front surfaces of the tube sheet and cover (including the internal sides) were blast-cleaned to the required standards (Sa 2.5 with a minimum surface roughness of 75 µm), followed by desalination and re-blasting. Pipes were plugged, and damaged areas were sealed with a 3–5 mm thick layer of Belzona 1111. After curing, the plugs were sanded and removed from both sides. Belzona 5892 was then applied in two sequential coats, achieving a total dry film thickness (DFT) of 500 µm.
