# FOUR STAGE SUBMERSIBLE RIVER WATER PUMP

ID: 9815

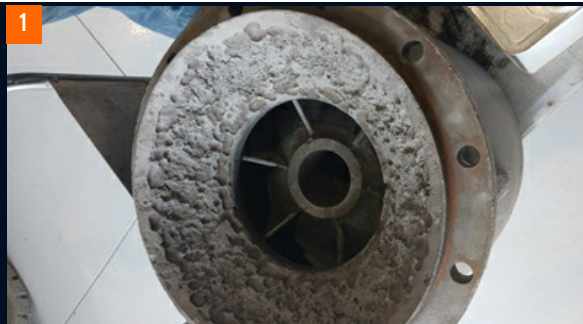
After many years of pumping river water the pump bowls had severe corrosion issues and required rebuilding

1. Bowl 1 Corrosion blasted and ready for rebuilding with Belzona 1111
2. Rebuilding started using Belzona 1111 application by short bristle brush
3. First bowl application completed
4. Two bowls completed and ready for machining

Pumps were dismantled by the CMF Millwrights and blasted and than cleaned using Belzona 9111, Belzona 1111 was mixed using the Belzona tooling and application started by using a short bristle brush to fill heavy corrosion areas and finished using a Belzona applicator.
