# PLATE BONDING REPAIR ON GLASS INFUSED TANKS ENSURES INTEGRITY OF TANK

ID: 9817

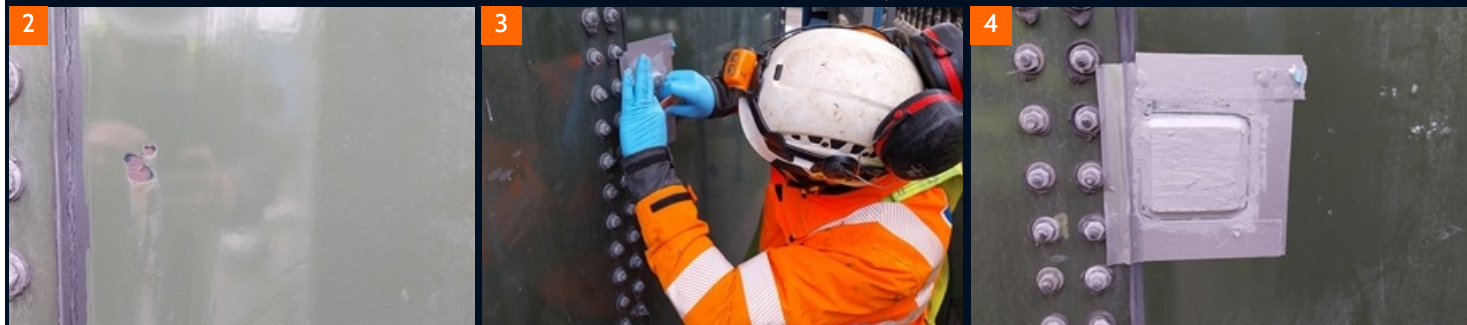
Sludge tanks for treatment works required several repairs for external corrosion on glass steel infused tank

1. Inspection of sludge tanks to assess repair needs
2. Several areas of external corrosion/damage were identified
3. Carbon fibre plates were bonded using Belzona 1111
4. The solution ensures that no further corrosion can spread and weaken integrity of tank

The surface of the tank was prepared with hand tools to minimum surface preparation. Using carbon fibre plates, the plates were bonded using Belzona 1111 to seal and ensure no further ingress of corrosion would affect the tank
