# PLATE BONDING ON SLUDGE TANKS FIXES EXTERNAL CORROSION ISSUE

ID: 9818

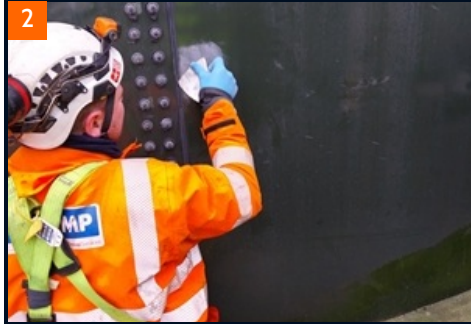
1. Inspection of sludge tanks to assess repair needs
2. Several areas of external corrosion/damage were identified
3. Carbon fibre plates were bonded using Belzona 1111
4. The solution ensures that no further corrosion can spread and weaken integrity of tank

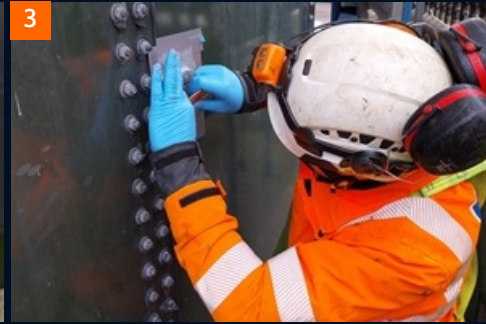
Sludge tanks for treatment works required several repairs for external corrosion on glass steel infused tank
