# BELZONA PROTECTS CW PIPES AND BENDS

ID: 982

Main intake pipework drawing sea water into the power station.

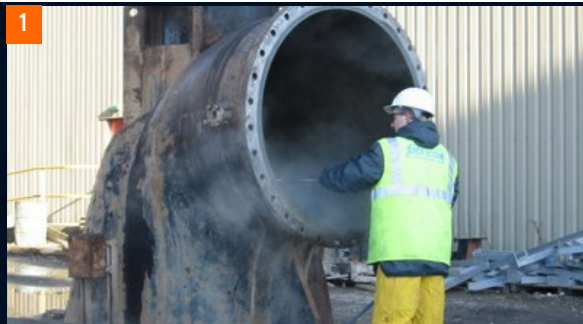
As a relatively new power plant on the banks of tidal estuary, the CW pumps and ancillary pipe work were showing significant erosion and corrosion after a short period of service. They were pumping large volumes of water from the river, which is very erosive even after it has been screened.

1. Bend being power washed to remove salts
2. & 3. Coated bend

Application was carried out in accordance with Belzona System Leaflets VPF-1 & VPF-2. Particular attention was paid to washing and blasting to remove salts, then badly eroded areas were re-built with Belzona® 1311 and then two coats of Belzona® 1321 applied.

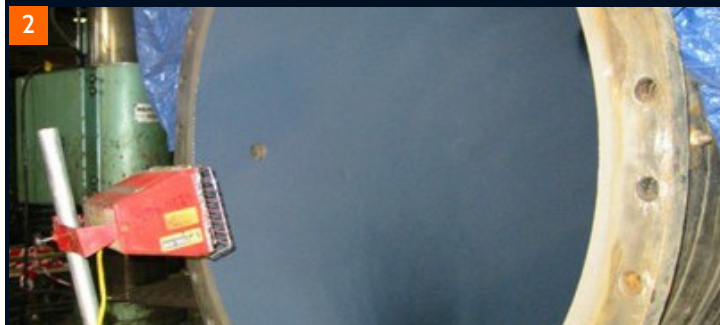
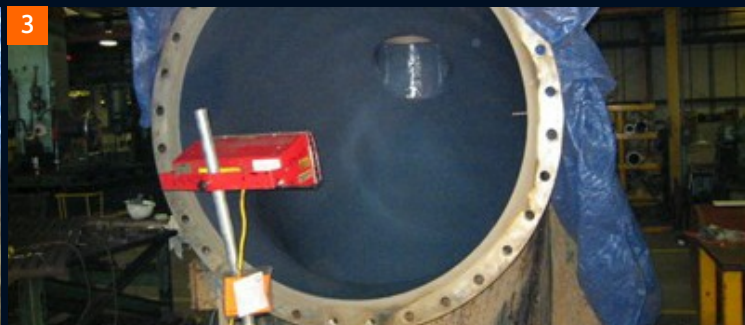
The first bend, which is shown in the photographs, was opened up in March 2007 with a view to being refurbished. However when it was inspected, it was found to be in perfect condition.
