# COOL RUNNINGS WITH BELZONA FLOOR REPAIRS

ID: 9821

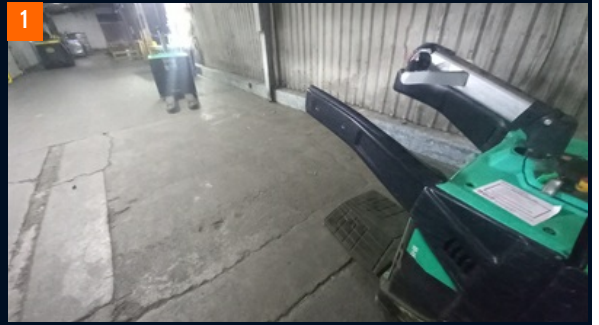
A cold storage freezer floor area was breaking up due to traffic & low temperatures. A fast back to service repair was required to be carried out over a weekend so production was not impeded.

1. Gaps & cracks leaving trip hazards on the floor
2. Grinding out of defective areas
3. Belzona 4131 application
4. Completed Belzona 4131 areas & Belzona 4521 applied
