# MARINE FLOATING FLEXIBLE HOSES REPAIR WITH BELZONA ELASTOMERIC POLYMERS

ID: 9822

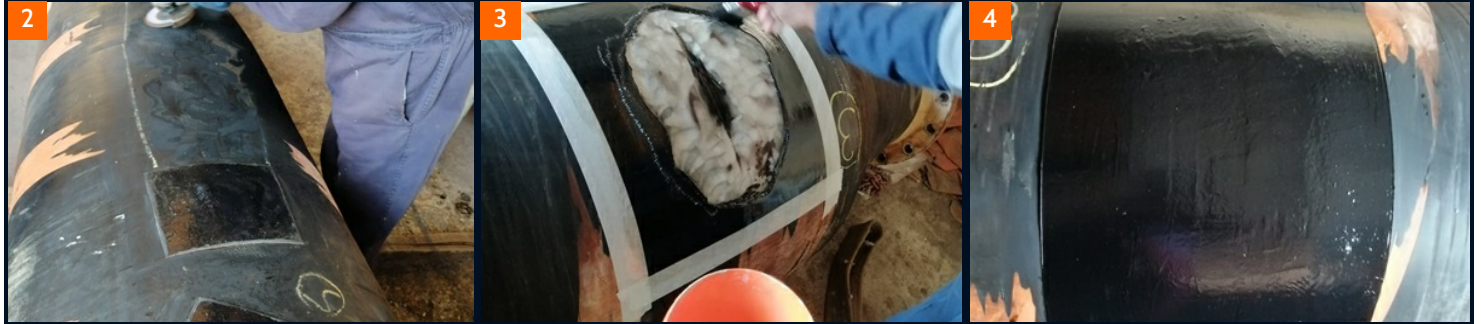
## PHOTOS

The marine floating hoses sustained damage and tearing as a result of collisions with vessels and boats.

1. Floating hose was damaged due to collisions with ships and boats
2. Surface preparation by hand and power tool
3. Application of 2921 (Elastomer GP Conditioner) prior to application of Belzona elastomeric systems
4. Belzona application 2211 (MP Hi-Build Elastomer) and 2111 (D&A Hi-Build Elastomer)

- 1- Surface preparation by hand and power tools(grinder, MBX)
- 2- Remove all loose surface contamination and residue with a cleaner
- 3- Application of Belzona 2921 (Elastomer GP Conditioner)
- 4- Application of 1st layer Belzona 2211 (MP Hi-Build Elastomer)
- 3-Application of 2nd layer Belzona 2111 (D&A Hi-Build Elastomer)
