# FORKLIFT DAMAGE FROM EXPANSION JOINT SOLVED BY BELZONA 2211

ID: 9825

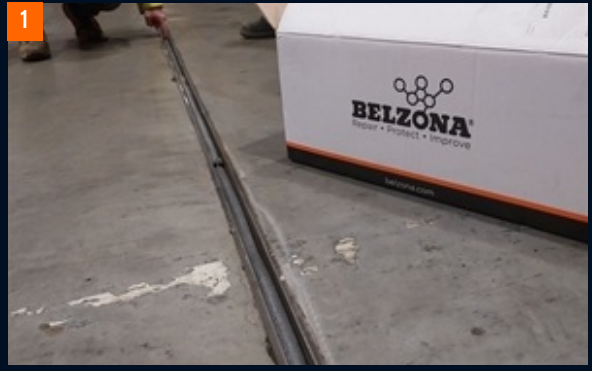
Expansion joints were widening beyond control and causing unnecessary damage to the hundreds of forklift truck wheels and damaging suspension in the large distribution centre

1. Expansion joints had separated over three decades, causing damage to forklifts operating in the area
2. The area is suitably prepared and Belzona 2211 is then used to fill the area
3. Application is completed and surface area is reprofiled
4. Solution is completed, sealing joint and has shown no sign of wear or deterioration protecting forklifts from damage

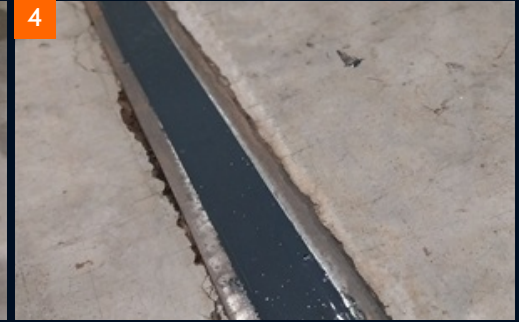
The joint has now been in place almost half of the year and is showing no sign of wear or deterioration, protecting the stackers and reducing damage to the machinery
