# BLADE REPAIR AND PROTECTION WITH BELZONA 5711 AND BELZONA 5721

ID: 9828

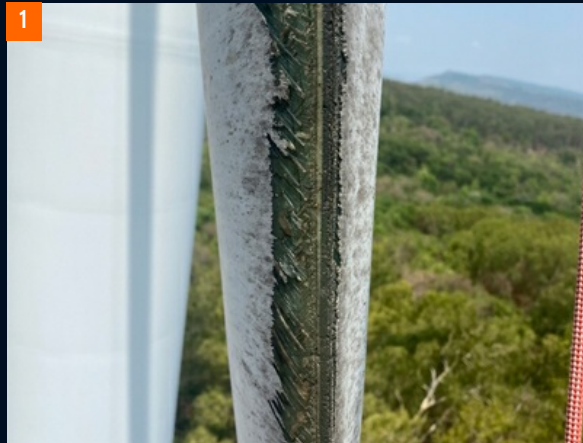
Pitting damage and coating deterioration because of rain erosion and UV attack at leading edge area.

1. Damage on the blade.
2. Surface preparation.
3. Application of Belzona 5721
4. Completed application
