# RAISED FLANGE FACE REBUILD

ID: 9829

Valve body flange was experiencing corrosion and metal loss

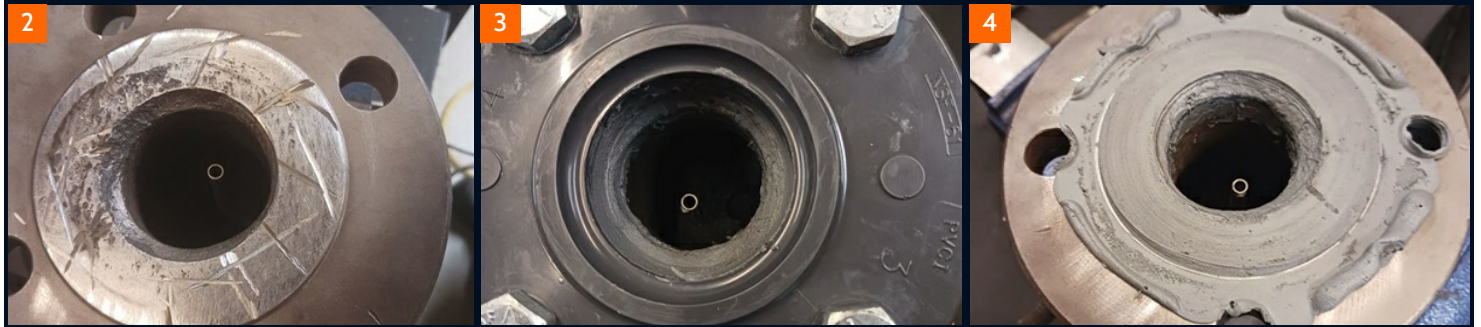
1. Former ready with Belzona 9411 applied
2. Surface Preparation completed of the flange
3. Belzona 1111 placed on flange and former, former bolted to valve body and torqued into place.
4. Belzona 1111 now cured and ready for final clean up.

Application was carried out by following the VPF-13 and VPF-17 system leaflets.
