# FREEZE PLUG REINFORCEMENT ON CUMMINS 6.7L ENGINE

ID: 9830

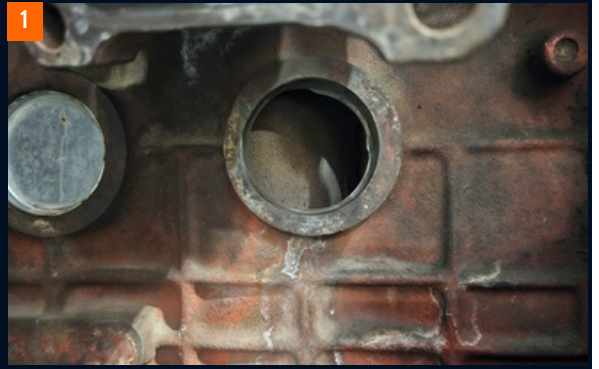
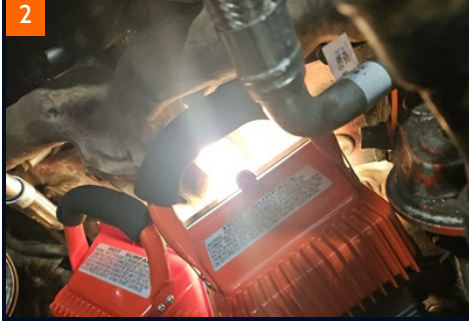
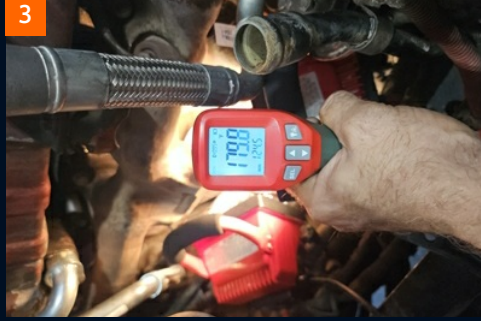
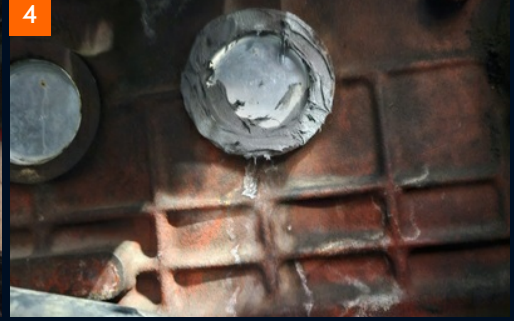
Persistent leakage at the 7 o'clock position of a freeze plug on a Cummins 6.7L engine. The plug had been previously installed twice using two different sealing compounds, but leakage continued under operational conditions (210–220°F)

1. Engine block area with the freeze plug removed, exposing the internal cavity before repair.
2. Controlled heat being applied to the engine block area using portable lamps to ensure proper curing of the repair material.
3. Infrared thermometer reading 179.8 °F during heat-curing process of the epoxy sealant on the engine block.
4. Freeze plug installed and sealed with epoxy compound after completing the engine block repair.

Surface preparation was performed by mechanically abrading the plug, cavity, and surrounding area to achieve optimal surface profile for adhesion. Edges were chamfered and masking tape was used to mark the rebuild zone. Belzona 1511 was mixed until homogeneous and applied using the stipple technique. The plug was inserted under pressure, ensuring product displacement around the perimeter, then excess material was used to reinforce the surrounding chamfered zone. After initial ambient curing (3 hours at ~86°F), localized heat was applied to raise the temperature to 140°F for 2–3 hours, increasing the system's heat resistance and final performance.
