# SUPERWRAP II REPAIRS ON LARGE DIAMETER COOLING WATER PIPE

ID: 9831

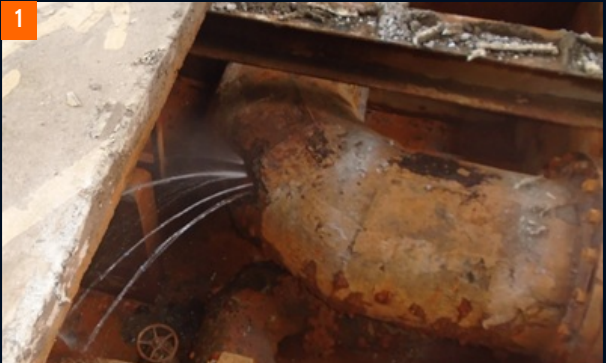
A cooling water pipe had several through wall defects. These had come from years of erosion & corrosion. The site depended on this pipe for production.

- 1. Leaking area on bend
- 2. Close up of defects
- 3. Wrap applied and consolidated
- 4. Completed repair

The pipe was prepared using an MBX Bristle Blaster to the SSPC SP-11 surface preparation standard. More defects appeared during this process. All of the defects were plate bonded using pre fabricated Superpatch plates & Belzona 1161 UW Metal. Belzona 1981 was then applied & consolidated to reinforce these areas.
