# WATER TANK SPRUNG LEAK

ID: 9835

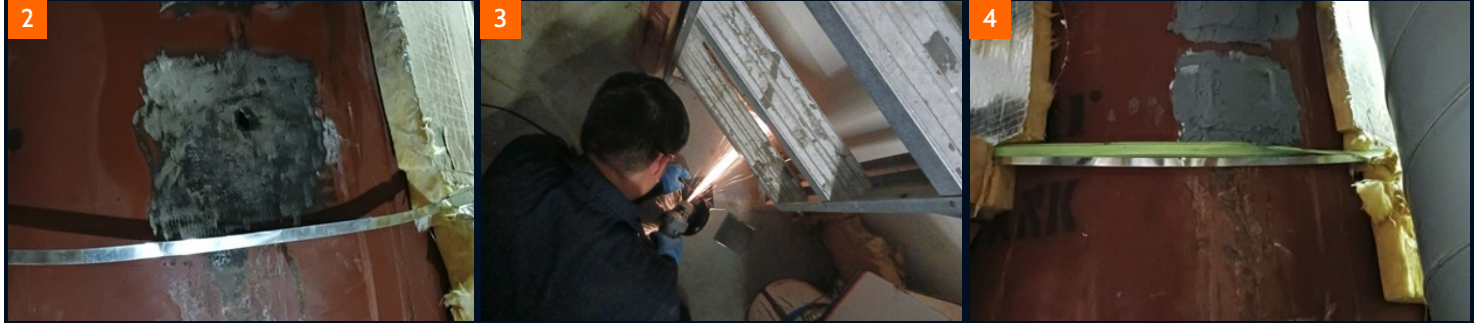
## PHOTOS

Water tank was experiencing corrosion issues from many years of use

1. Preparation in progress at corrosion and holed area on water tank.
2. Repair areas on water tank ready for cold bonding of the new plates.
3. Preparation in progress of the new cold bonding plates.
4. New cold bonded plates applied to tank using Belzona 1111

Method used was cold bonding new plates at repair areas, tooling used was a grinder with a 80 grit sanding disc and grinding wheel.
