# IN-SITU FAN SHAFT REBUILD

ID: 9838

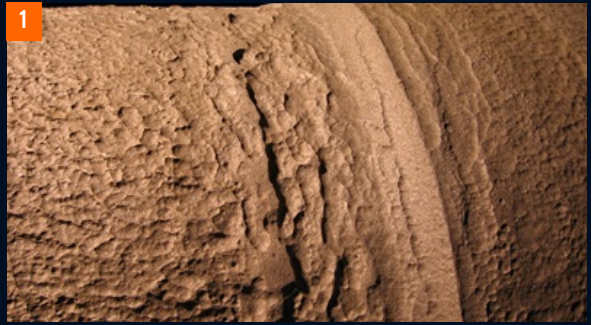
Pitting corrosion was causing balance issues. A new part was months from being procured.

1. Severe Pitting Corrosion
2. Belzona 1311 being applied to rebuild damaged areas
3. Belzona 1321 brush applied

Area was grit blasted and degreased. Then Belzona 1311 was applied to the damaged areas followed by two coats of Belzona 1321.
