# "DUCKS FEET" REFURBISHED WITH BELZONA

ID: 984

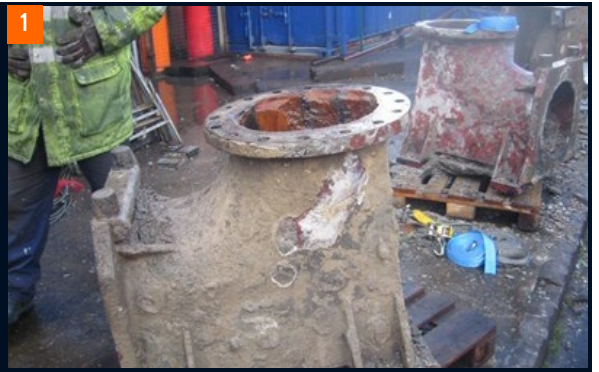
After 10 years in service these "ducks feet", situated at the bottom of the CW pipework, were found to be in very bad condition. There were 4 units to re-furbish.

1. As they arrived at contractor
2. Internal view showing severe damage
3. After blasting and re-building with Belzona 1311
4. Fully coated with Belzona 1321, looking rather better than when they arrived!

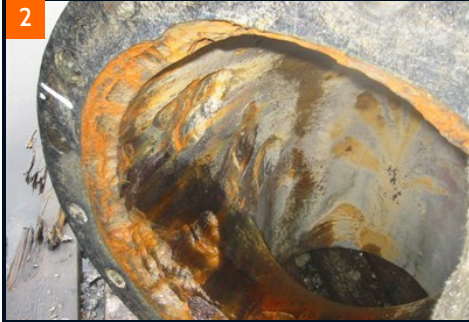
Severe erosion, corrosion to body. The Power Station tried to order new ones but were told the delivery was upwards of 6 months! As they were right at the end of the shutdown this was not suitable.
