# BRIQUETTER ROLL SHAFT

ID: 9840

## PROBLEM

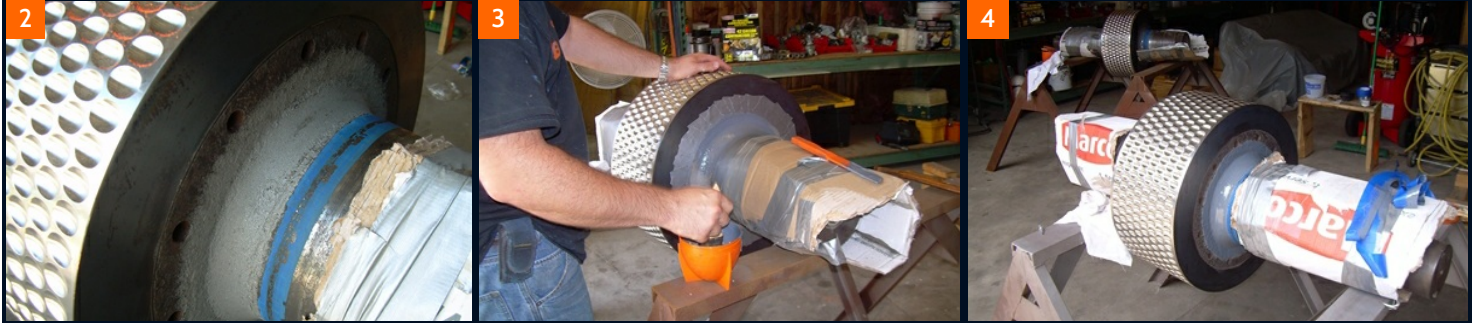
## PHOTOS

This Briquetter Roll Shaft (with 72 almond pockets) was experiencing pitting corrosion from making salt briquettes.

1. Damaged area taped off
2. Surface prepped and ready for Belzona product
3. Applying Belzona 1391HT
4. Finished application

First, the area is masked off with duct tape especially the machined surfaces are protected against grit blasting and/or accidental contact. The area to be coated is grit blasted with Black Beauty Coal Slag and coated with one coat of Belzona® 1391HT
