# AIR HANDLER SHAFT REPAIR WITH BELZONA 1111

ID: 9841

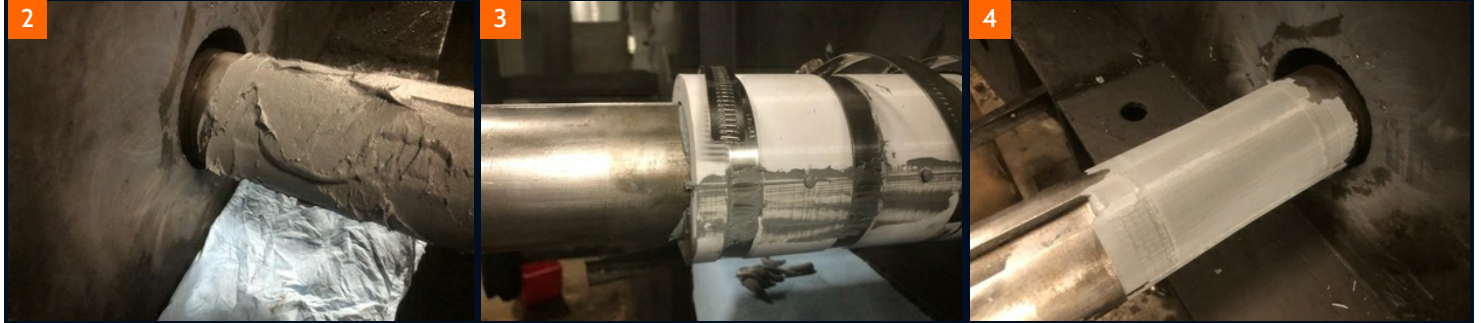
## PHOTOS

Due to corrosion the shaft was out of balance creating vibration to the air handling unit.

1. Close up of the pitting corrosion
2. Belzona 1111 applied to the shaft
3. Former put in place
4. Finished job

This shaft was cross-hatch ground then thoroughly degreased using Belzona 9111. Then Belzona 1111 was applied according to the Instructions For Use. A former was used and product allowed to cure. Upon removal of the former the Belzona was sanded smooth and mic'd for clearances.
