# BELZONA SOLVES SPECIAL PUMP PROTECTION PROBLEM

ID: 9844

The customer had a long-term problem with this special 6-stage mixing pump in terms of corrosion.

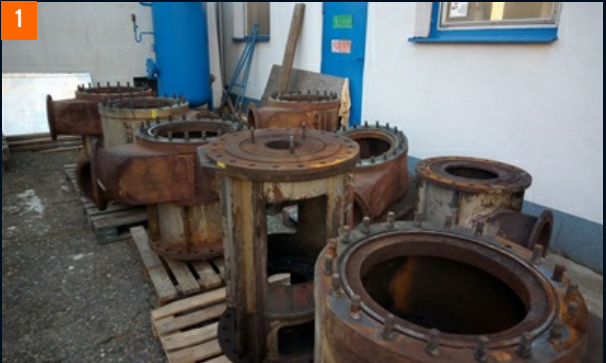
- 1. Corrosion damaged equipment
- 2. Blasting equipment for Belzona product application
- 3. Belzona 4111 was used to fill the pitting corrosion
- 4. Mixing pump parts before shipment

Blasting of individual parts, chemical cleaning, sealing of affected parts with Belzona 4111, application of Belzona 4331 coating, and finally we also implemented an external protective coating.
