# SF6 LEAK CONTAINED WITH BELZONA SF6-FIX COMPOSITE REPAIR

ID: 9849

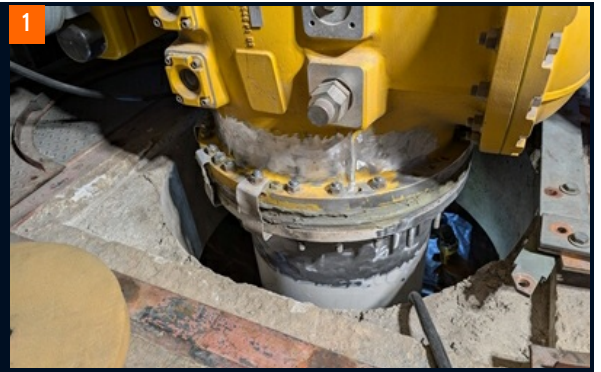
1. Application Area after surface preparation was completed
2. Belzona 7311 being applied onto the Breathing membrane
3. Belzona 7311 applied with reinforcement mesh
4. Completed Belzona SF6 leak repair system

The surface was prepared using grinders, but because of the 90-degree angle on the flange, we couldn't reach all areas evenly. To help with bonding in the section that wasn't properly prepared, we applied Belzona 7311 with Belzona 9341 directly to that part of the flange face before putting the breathing membrane in place. Next, we placed a membrane over the entire flange and applied Belzona 7311 with Belzona 9341 reinforcement tape. To complete the repair, we overwrapped the area with Belzona 1982 and Belzona 9371 reinforcement mesh, following the steps outlined in system leaflet GSS-14.
