# MAIN COOLING WATER PUMPS PROTECTED WITH BELZONA

ID: 985

## PROBLEM

Erosion corrosion particularly on main wearing rings, cut water and delivery tubes.

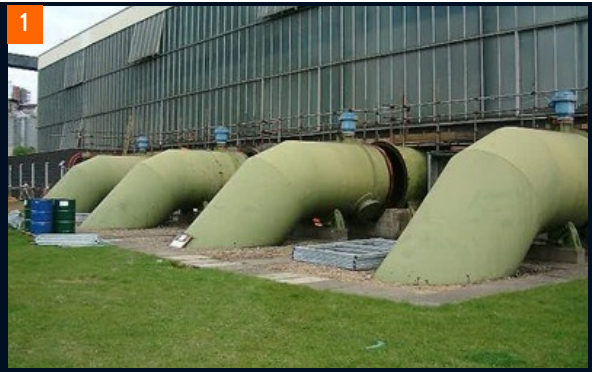
1. Scale of pumps can be gauged from the delivery tubes
2. Suction side coated
3. Degree of corrosion evident on the delivery tubes
4. Completed coating
